Report No. FAA-RD-80-10

EVALUATION OF ADVANCED NON-DESTRUCTIVE INSPECTION METHODS FOR AIRCRAFT TIRES

Donald D. Ewing
B F Goodrich Co.
Research and Development Center
9921 Brecksville Road
Brecksville, Ohio 44141

February 1980

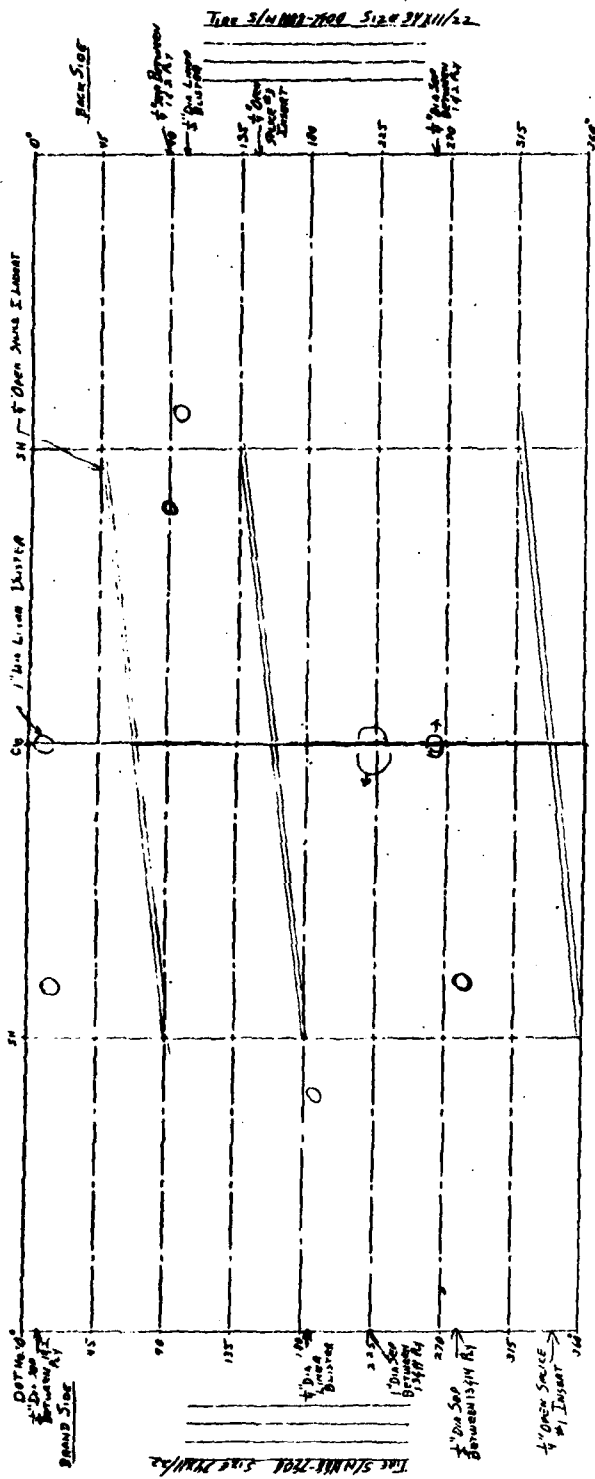
N88-7900

N 88 7900 - The information submitted with the tire, lists the following: 8 separations, 3 open splices. Ultrasound detected all eight possible separations, anomalous conditions in at least

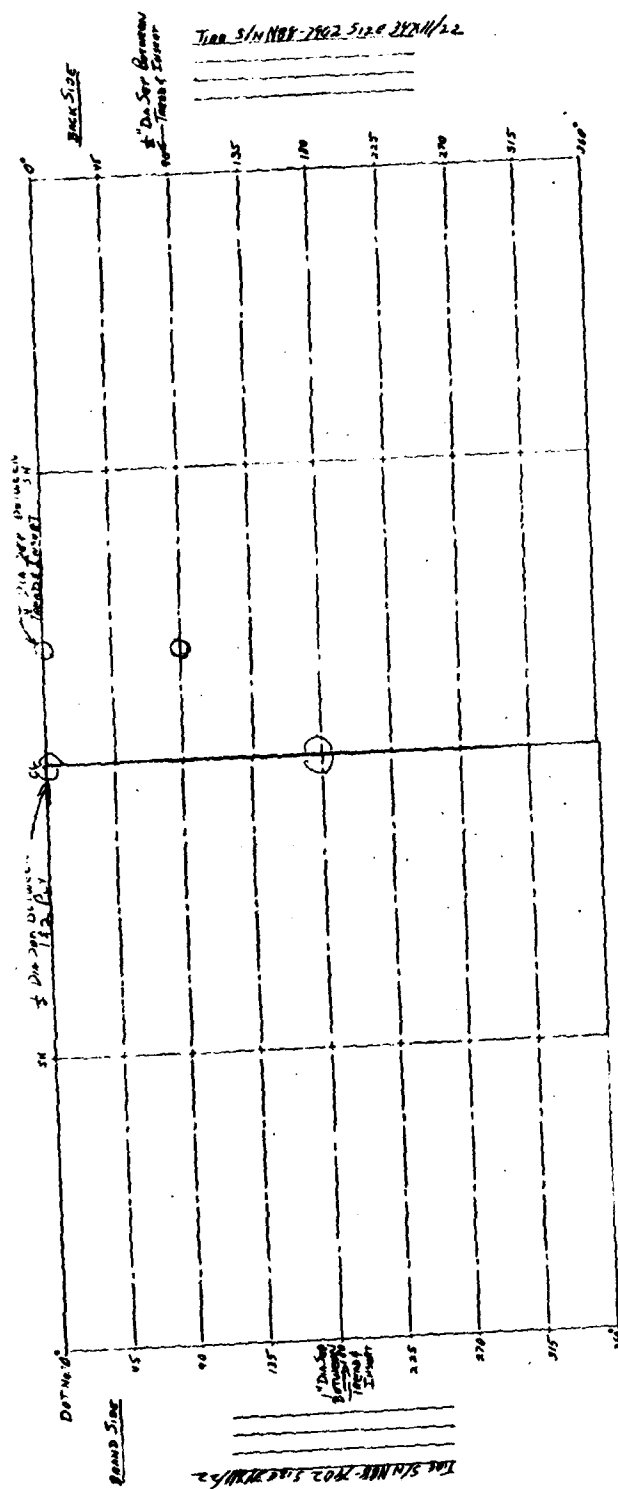
N88-7902

N 88 7902 - This was a retreaded tire marked RI. The information received with the tire indicated 4 separations. Analysis of ultrasonic data showed six areas having possible separations and two areas in which splices could be questioned. In three places the ultrasonic data and the data furnished with the tire agree.
